Service Information

Replacement of CV Joints on all Haflinger models

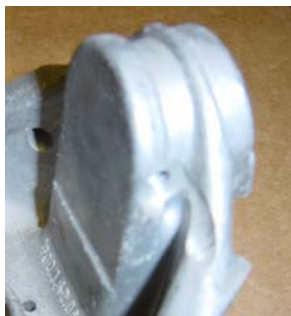
The main difference is in the clearance between the casting and the CV Joint, and where a later or replacement type joint has been fitted to an early housing there is insufficient clearance causing damage to the outer case of the CV joint or the rubber boot.

Early version

- Change the swivel housings for the later type
- Remove more metal from the casing by milling or grinding to a depth of **4mm**. In this case it is important not to remove too much material as the upper swivel pin hole will be infringed, causing grease to leak out.

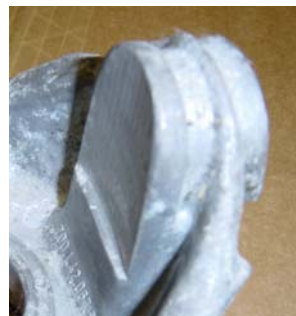
Later version with more metal removed
